FINAL PAVEMENT REPORT

Turlock Pavement Rehabilitation Location 1 – N. Johnson Road, Arbor Way, and Zinfandel Lane/Charles Place Neighborhood Turlock, California

May 8, 2025 Crawford File No. 23-931.3

Final Pavement Design Report

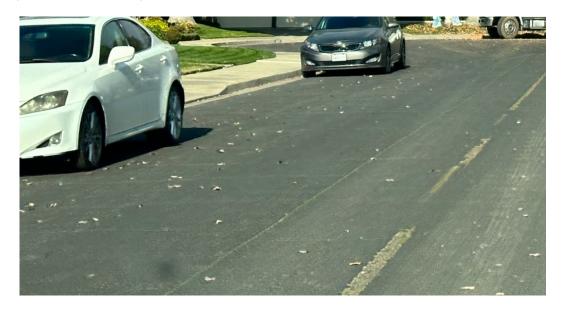
The streets included in this section were assigned a PCI above 50. This range of PCI correlates to pavement in generally fair to poor condition. The results of our pavement condition assessment generally agree with the assigned PCI values. We observed the streets in Section 1 to be in generally fair condition with low to moderate severity block cracks. Lack of maintenance was observed as vegetation was beginning to grow within the cracks and moderate to high severity raveling was present along all of the streets.

Photo 1: Section 1 Moderate Longitudinal Cracking

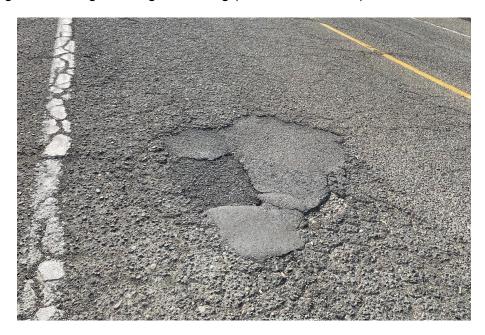
Section 2 represents the heavily distressed roadways with PCI values ranging between 0 and 41. A PCI value below 50 typically indicates heavy distress features (like potholes, alligator cracks, rutting,... etc) and surface treatments will likely not produce the desired end product. Pavement failure in Section 2 is evidenced by the high-severity potholes and heavy alligator cracks we observed during our pavement condition assessment. The patch efforts and filled potholes have failed and are cracks intruding into the patches. Outside of the potholes, we observed high-severity alligator cracking, raveling and rutting (see Photo 2 below).

Photo 2: Section 2 Raveling, Alligator Cracks and Failed Patching
